Manhole Inspection Summary

Manhole # S11EE1004MH

Location Address: **4216 TOWANDA AVE**

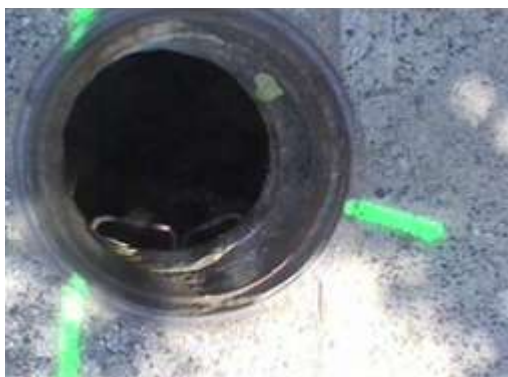
Top View

Offset: **3** (in.)

Condition: ☒ Sound ☐ Cracked ☐ Leaks

FRAME OFFSET

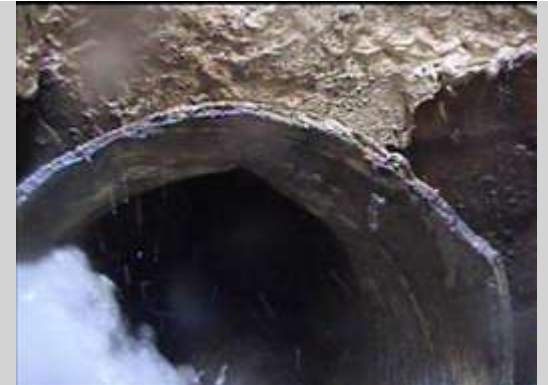
12 O'Clock Outflow

18 in. Circular Gravity Sewer
Pipe Out @ 12 O'Clock

Pipe Height: **19.2** (in.) Rod and Bar (Angled)
Pipe Material: **PVC** ☐ Pipe Lined
Invert Depth: **12.00** (ft.) Flow Characteristics: **Turbulent**
Deposits: ☒ None ☐ Mud ☐ Sludge ☐ Debris ☐ Grease
Silt Depth: (in.) Deposits Extent:
Infiltration: **None** Pipe Seal Cond: **Sound**

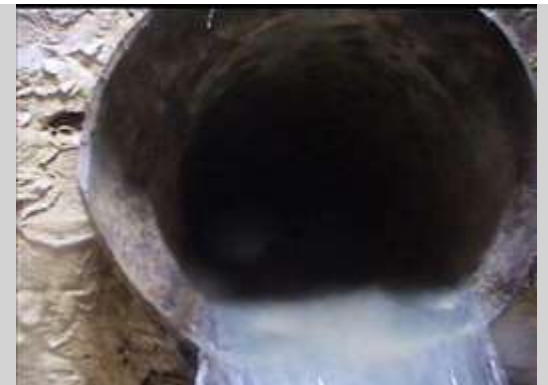
3 O'Clock Inflow

18 in. Circular Gravity Sewer
Pipe In @ 3 O'Clock

Pipe Height: **19.2** (in.) Rod and Bar (Angled)
Pipe Material: **PVC** ☐ Pipe Lined
Invert Depth: **9.60** (ft.) Flow Characteristics: **Turbulent**
Deposits: ☒ None ☐ Mud ☐ Sludge ☐ Debris ☐ Grease
Silt Depth: (in.) Deposits Extent:
Infiltration: **None** Pipe Seal Cond: **Sound**

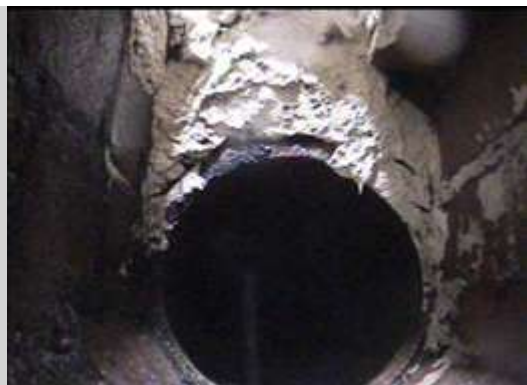
6 O'Clock Inflow

8 in. Circular Gravity Sewer
Pipe In @ 6 O'Clock

Pipe Material: **Clay** ☐ Pipe Lined

Invert Depth: **11.40** (ft.) Flow Characteristics: **Fast**

Infiltration: **None** Pipe Seal Cond: **Sound**
